**Flood Control Project Maintenance
Levee Inspections**
LMA District Cover Sheet
Spring 2011 Levee Inspection Results

Reclamation District No. 0404 Boggs

Levee Inspection Report By Mile - Spring 2011

Waterway						Bank	Unit Miles	Inspection Start/End	Inspector	
Unit No. 01 San Joaquin River						Right	2.36	04/14/2011 04/14/2011	Richard Willoughby	
LMR No.	Levee Mile		Category	Item	Location	Rating	Action/Comment	GPS Latitude/Longitude		Issue No.
	Start	End						Start	End	Photo
1	0.00	2.36	Earthen Levee	Vegetation	LS	M	Control annual grass and weeds on the levee slopes and easements.	37.942105 ° -121.345183 °	° °	13
2	0.00	2.36	Earthen Levee	Vegetation	WS	M	Control annual grass and weeds on the levee slopes and easements.	37.942103 ° -121.345182 °	° °	14 Y
3	0.03	0.48	Earthen Levee	Vegetation	LS	W	Remove the wild growth other than native grasses from the levee slopes.	37.941695 ° -121.344917 °	37.939652 ° -121.338373 °	5 Y
4	0.03	0.20	Earthen Levee	Vegetation	WS	W	Remove the wild growth other than native grasses from the levee slopes.	37.941697 ° -121.344917 °	37.939853 ° -121.343210 °	8 Y
5	0.21	0.25	Supplemental	DWR Erosion Survey	WS	U	Inspector Comments: 9/07/2010: No significa

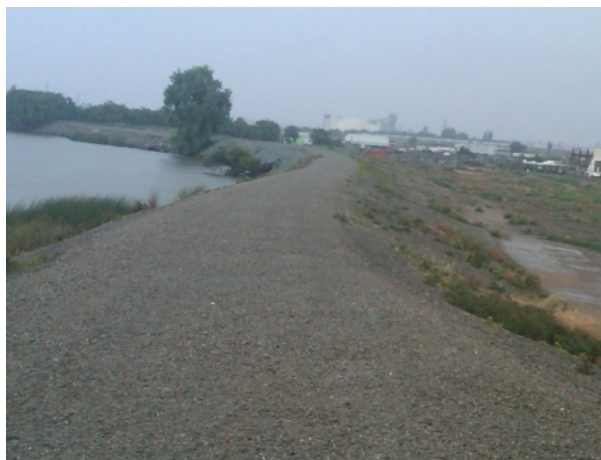
Levee Mile Report Line	2
Start Levee Mile	0.00
End Levee Mile	2.36
Location	Water Side
Category	Earthen Levee
Item	Vegetation

Looking upstream at typical view of levee.

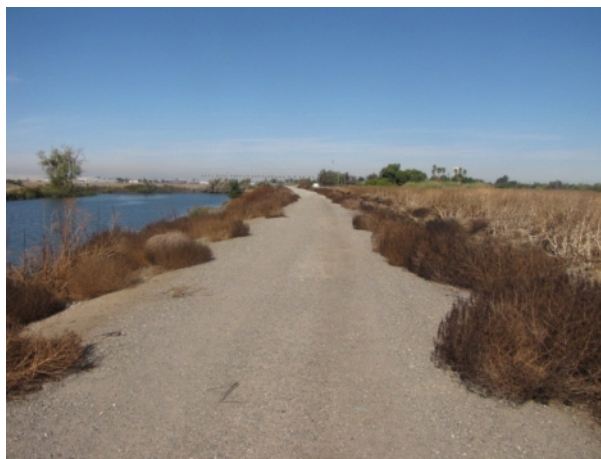
Levee Mile Report Line	3
Start Levee Mile	0.03
End Levee Mile	0.48
Location	Land Side
Category	Earthen Levee
Item	Vegetation

Looking north at modest vegetation on landside and waterside slopes.

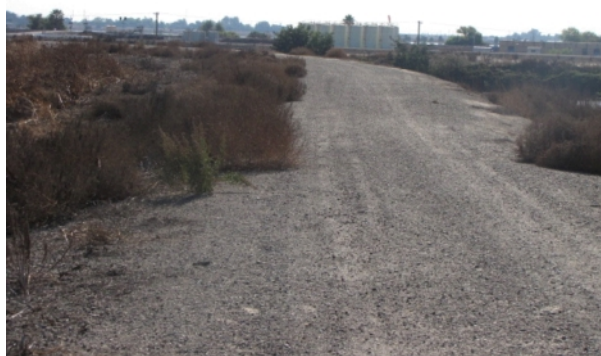
Levee Mile Report Line	4
Start Levee Mile	0.03
End Levee Mile	0.20
Location	Water Side
Category	Earthen Levee
Item	Vegetation

Looking south modest vegetation on waterside slope.

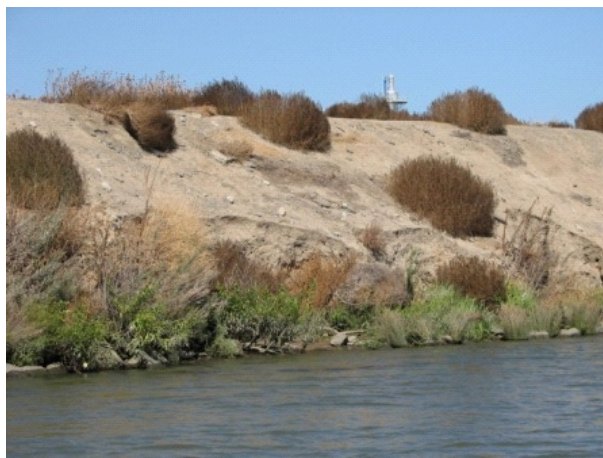
Levee Mile Report Line	5
Start Levee Mile	0.21
End Levee Mile	0.25
Location	Water Side
Category	Supplemental
Item	DWR Erosion Survey

Upstream view of Site 1 at RM 41.14.

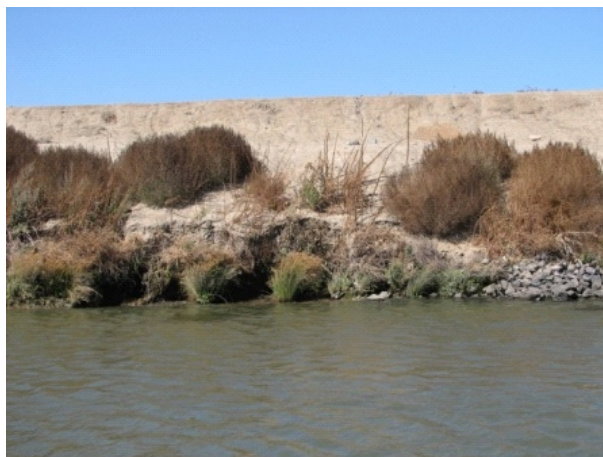
Levee Mile Report Line	5
Start Levee Mile	0.21
End Levee Mile	0.25
Location	Water Side
Category	Supplemental
Item	DWR Erosion Survey

Front view of Site 1 at RM 40.98.

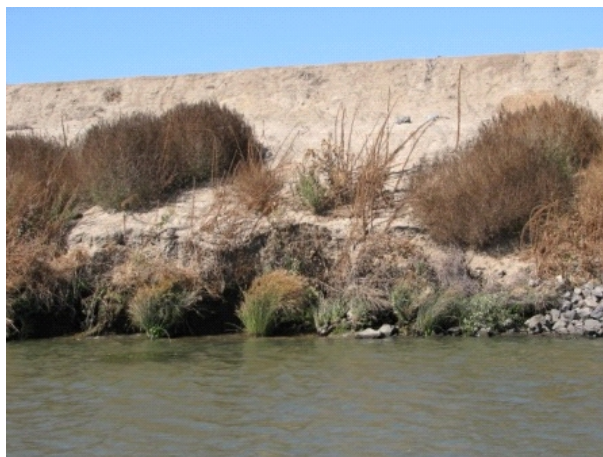
Levee Mile Report Line	5
Start Levee Mile	0.21
End Levee Mile	0.25
Location	Water Side
Category	Supplemental
Item	DWR Erosion Survey

Front view of site 2 at RM 40.93.

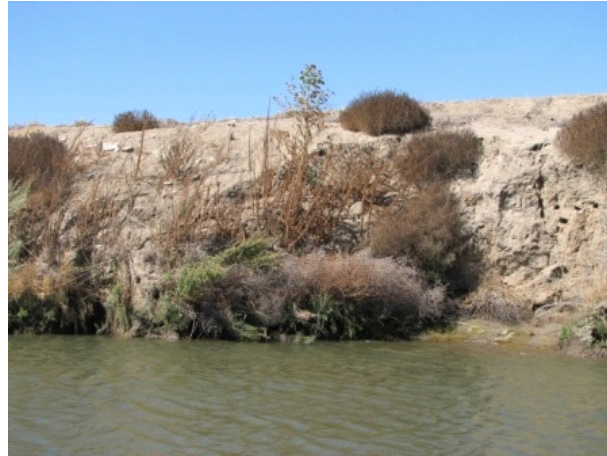
Levee Mile Report Line	5
Start Levee Mile	0.21
End Levee Mile	0.25
Location	Water Side
Category	Supplemental
Item	DWR Erosion Survey

Front view of site at RM40.86.

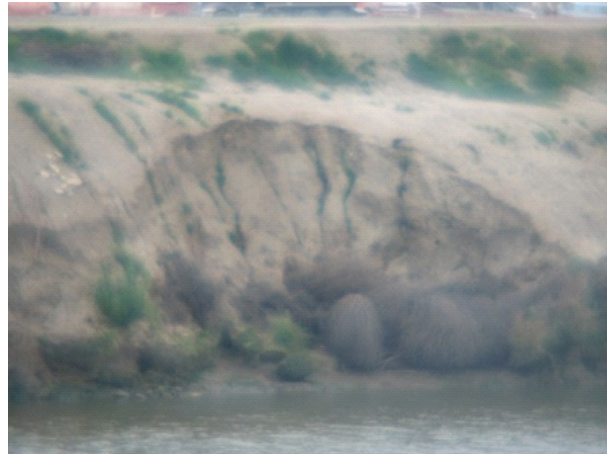
Levee Mile Report Line	6
Start Levee Mile	0.24
End Levee Mile	0.27
Location	Water Side
Category	Earthen Levee
Item	Erosion / Bank Caving

Erosion from LM 0.24 to 0.27

6	0.24	0.27	Earthen Levee	Erosion / Bank Caving	WS	M	Note and monitor erosion site.	37.939430 ° -121.342620 °	37.939430 ° -121.342620 °	6 Y
7	0.75	0.75	Earthen Levee	Vegetation	LS	M	Elderberries are blocking visibility and flood fight capability.	37.937758 ° -121.334149 °	37.937758 ° -121.334149 °	7 Y
8	0.96	0.96	Earthen Levee	Vegetation	LS	M	Elderberries are blocking visibility and flood fight capability.	37.935990 ° -121.331600 °	37.935990 ° -121.331600 °	2
9	1.56	1.56	Earthen Levee	Repair Gates	CR	C	Inspector Comments: Not able to access levee due to no key to lock. Not able inspected for LM 0.80 to 1.55	37.929048 ° -121.327253 °	37.929048 ° -121.327253 °	10
10	1.57	1.67	Earthen Levee	Animal Control	LS	M	No rodents visible, but rodent burrows visible; need to backfill and compact or grout burrows.	37.928723 ° -121.327207 °	37.927945 ° -121.325933 °	9
11	1.63	1.63	Earthen Levee	Slope Stability	WS	M	Repair slope instability.	37.928208 ° -121.326608 °	37.928208 ° -121.326608 °	12 Y

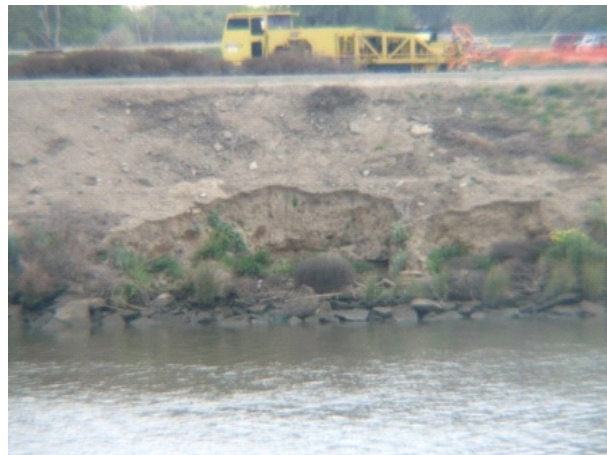
Levee Mile Report Line	6
Start Levee Mile	0.24
End Levee Mile	0.27
Location	Water Side
Category	Earthen Levee
Item	Erosion / Bank Caving

Erosion at LM 0.27

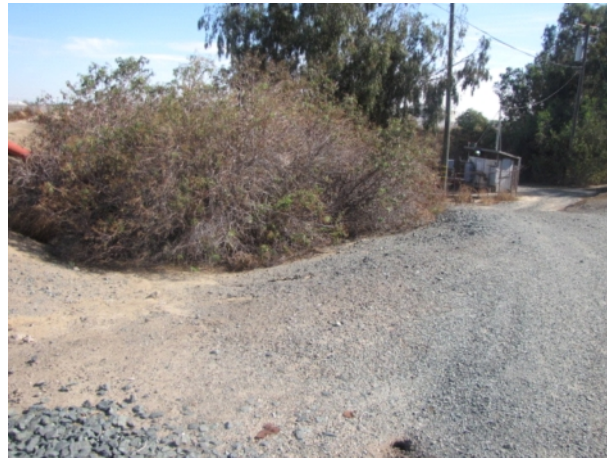
Levee Mile Report Line	7
Start Levee Mile	0.75
End Levee Mile	0.75
Location	Land Side
Category	Earthen Levee
Item	Vegetation

Looking southeast at elderberry on landside slope.

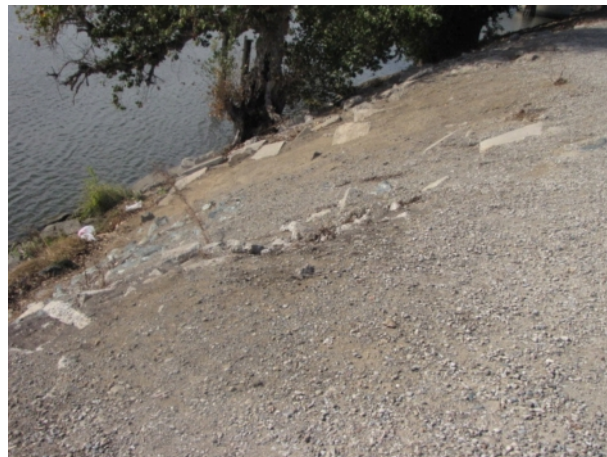
Levee Mile Report Line	11
Start Levee Mile	1.63
End Levee Mile	1.63
Location	Water Side
Category	Earthen Levee
Item	Slope Stability

Looking southwest at minor slope sliding on waterside slope.

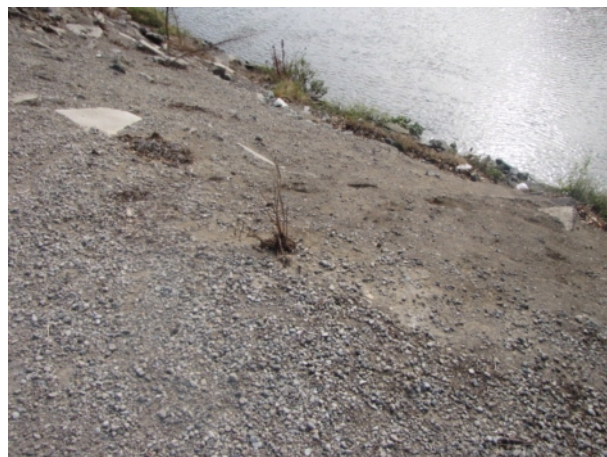
Levee Mile Report Line	11
Start Levee Mile	1.63
End Levee Mile	1.63
Location	Water Side
Category	Earthen Levee
Item	Slope Stability

Looking southeast at minor slope sliding on waterside slope.

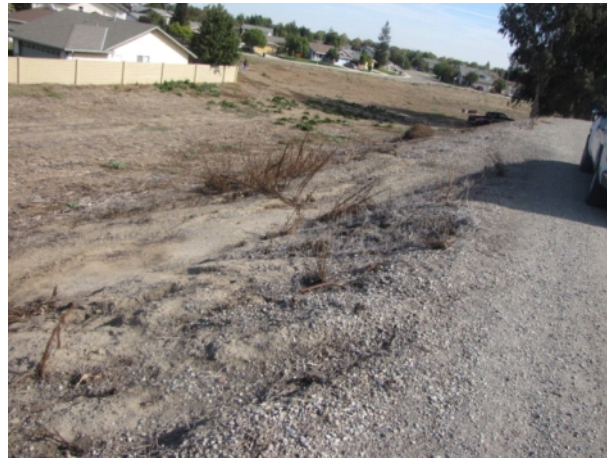
Levee Mile Report Line	12
Start Levee Mile	1.64
End Levee Mile	1.65
Location	Land Side
Category	Earthen Levee
Item	Slope Stability

Looking northeast at minor slope damage on landside slope cause by vehicle traffic.

12	1.64	1.65	Earthen Levee	Slope Stability	LS	M	Repair the levee slope damaged by vehicle traffic and prevent access where possible.	37.928118 ° -121.326338 °	37.927970 ° -121.326007 °	11 Y

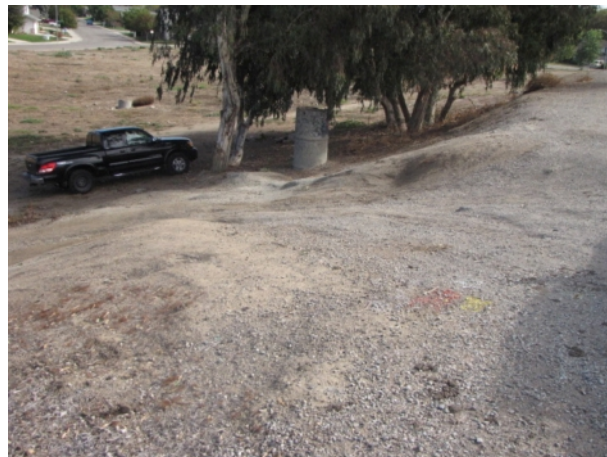
Levee Mile Report Line	12
Start Levee Mile	1.64
End Levee Mile	1.65
Location	Land Side
Category	Earthen Levee
Item	Slope Stability

Looking northeast at slope damage on landside slope cause by vehicle traffic.

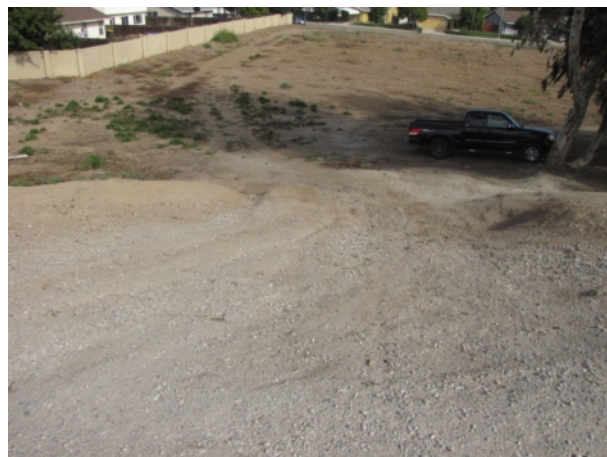
Levee Mile Report Line	12
Start Levee Mile	1.64
End Levee Mile	1.65
Location	Land Side
Category	Earthen Levee
Item	Slope Stability

Looking east at slope damage on landside slope.

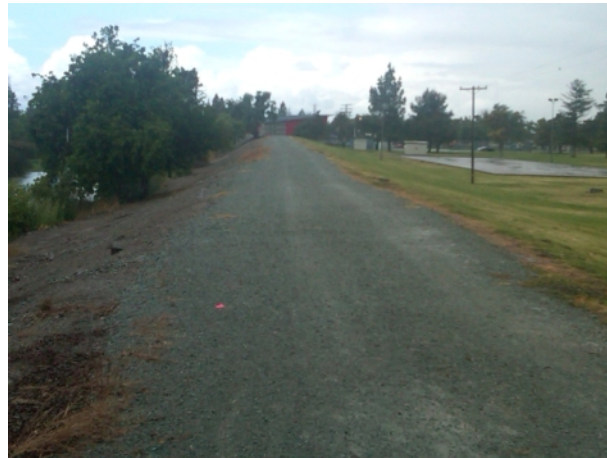
Levee Mile Report Line	2
Start Levee Mile	0.00
End Levee Mile	1.76
Location	Land Side
Category	Earthen Levee
Item	Vegetation

Looking upstream at typical view of levee.

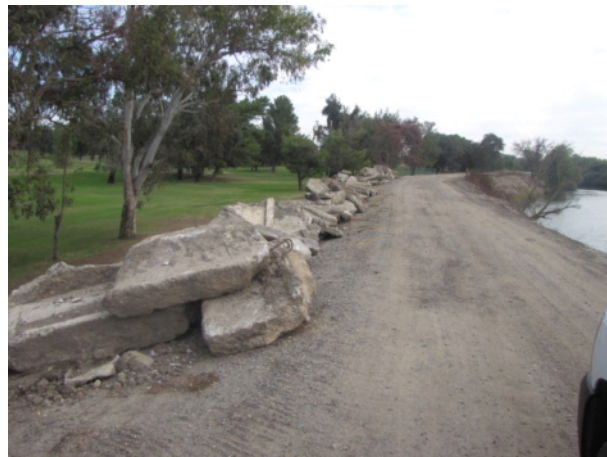
Levee Mile Report Line	3
Start Levee Mile	0.01
End Levee Mile	0.05
Location	Land Side
Category	Earthen Levee
Item	Encroachments

Looking south at concrete rubble with rebar on landside slope.

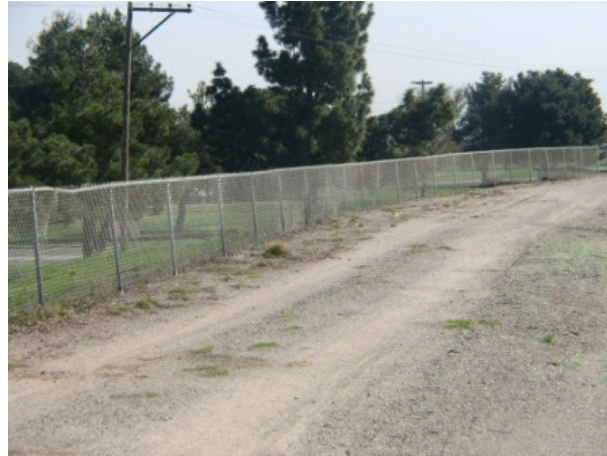
Levee Mile Report Line	11
Start Levee Mile	1.47
End Levee Mile	1.52
Location	Land Side
Category	Earthen Levee
Item	Encroachments

11	1.47	1.52	Earthen Levee	Encroachments	LS	PO	Fences	37.918440 ° -121.296707 °	37.918517 ° -121.295763 °	6 Y

Fence at landside shoulder from LM 1.47 to 1.52
